**Winter Contaminants on Surfaces During
Friction Tests at
Munich Airport – February 2000**

SMPL-LTR-2000-0234
TP 13658E

September 2000

For: Transportation Development Centre and Aerodrome Safety Branch of
Safety and Security, Transport Canada

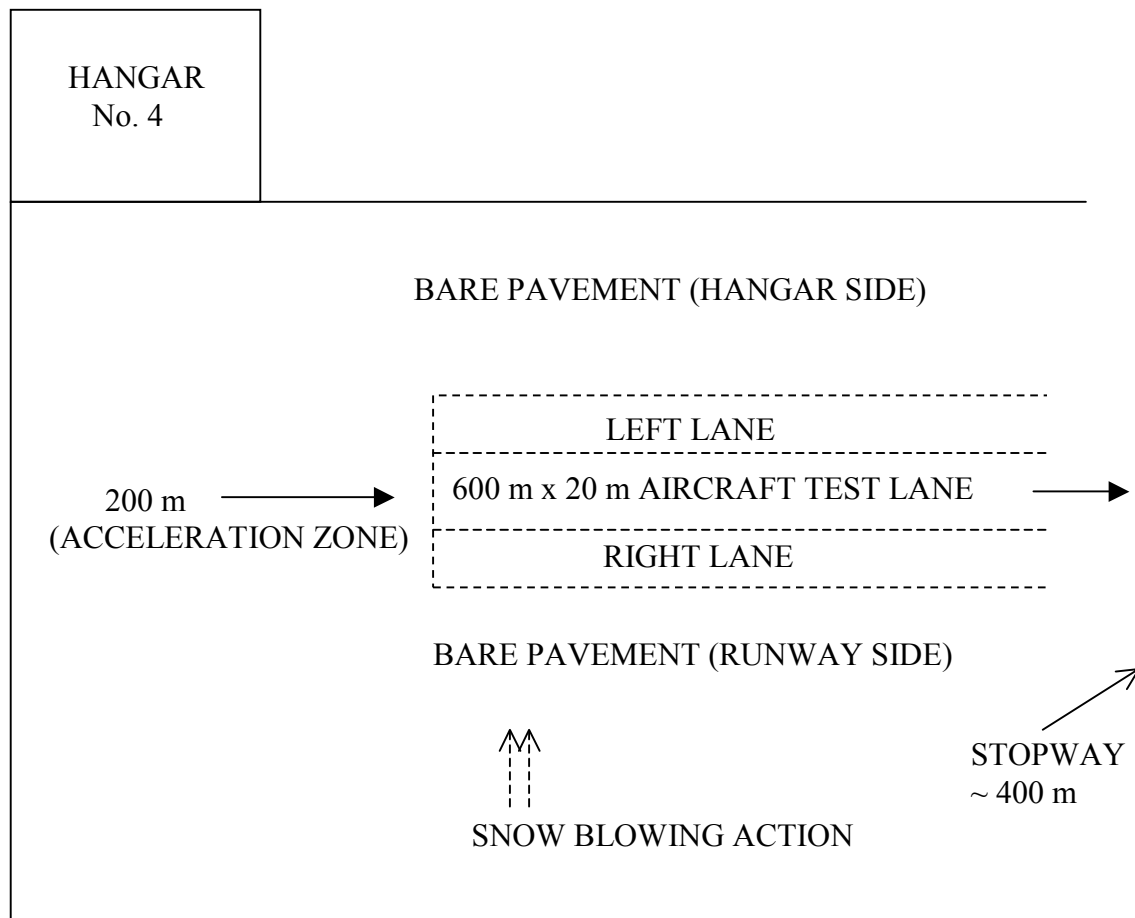
Figure 2. Schematic diagram of test site (not to scale)

According to the plan, this maintenance section was closed off for the specified duration of the friction measurements. Tests for both ground devices and aircraft were carried out in this section of the airport. Because of the generally warm weather, the surface of the 20 m wide and 600 m long test strip, as marked in Figure 1 with details given in Figure 2, were contaminated with stored snow from the disposal sites. A fleet of plough trucks and snowblowers was used in preparing the contaminated surfaces. A snow cannon, used for making artificial snow in a ski resort, was also acquired in the event that it did not snow during the test period, but the weather conditions were favourable to the production of artificial snow. This was stored in Hangar 4, which also provided a shelter for all the ground vehicles used in the tests.

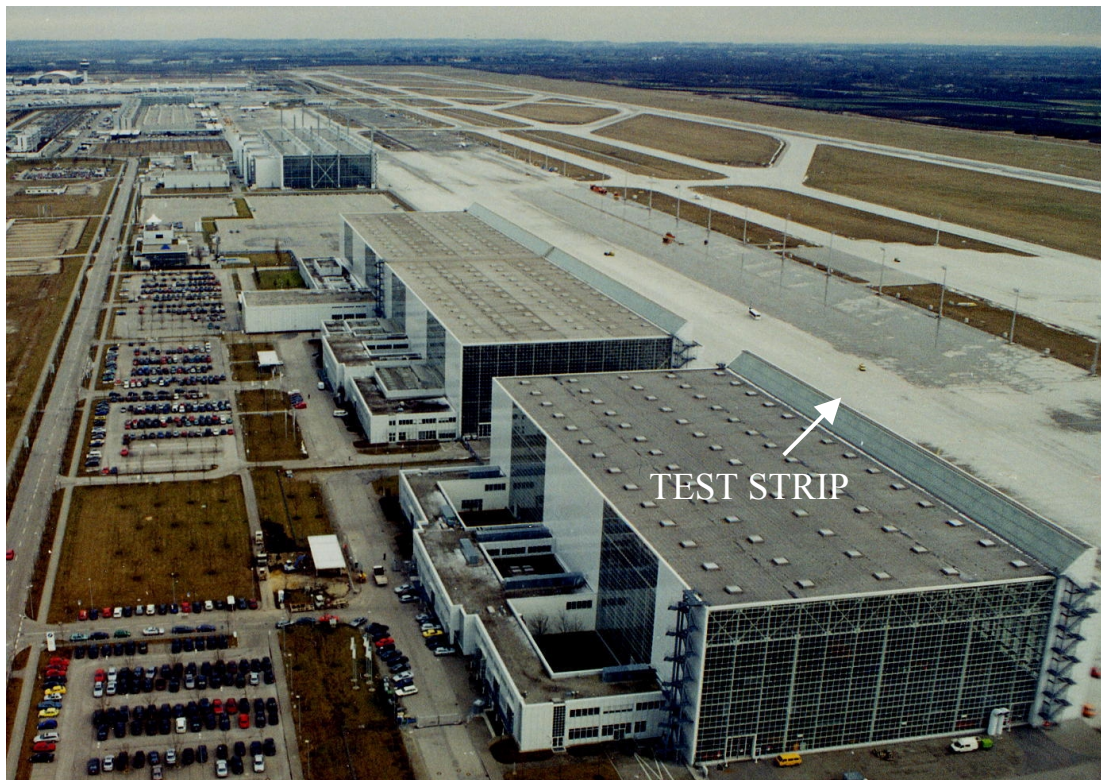
Figure 3. An aerial view, looking towards the 08 direction of the test strip (600 m x 20 m) on the maintenance ramp between the hangars and the 08-26 runway on the right

The air temperature was just above the freezing point at this time. The operation of building a man-made snow cover on the concrete surface of the test strip (600 m x 20 m) was very impressive. A number of hauling trucks brought moist and dense (density of about 700 kg.m^{-3}) snow from the storage area. This moist and compacted snow was dumped on the concrete surface along a row parallel to the length of the test strip. This row was about 20 m south of the runway side of the intended test strip (Figure 2). A powerful snowblower was then used to spread the snow on the test strip. It took about two hours to cover the entire test area with a layer of snow about 20 mm in thickness. After completion of the task of spreading, excess materials on both sides of the planned test strip were removed, leaving a stretch of groomed material on the test strip. An example of a man-made test bed of processed and stored snow can be seen on the right side (runway side) of the hangars in Figure 3.

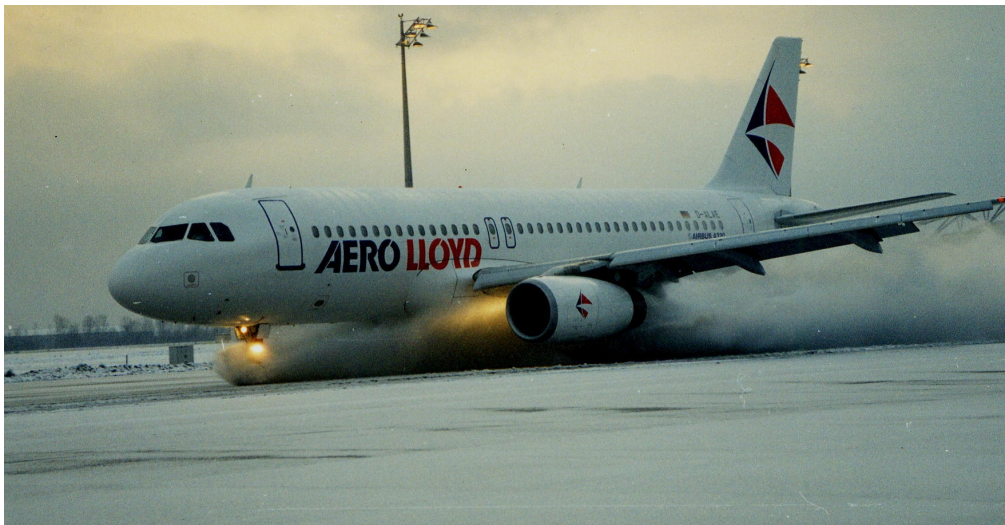
Figure 6. View of Aero Lloyd Airbus A320-DALAE aircraft during a braking run on Monday 21 February 2000. Note the freshly fallen snow in the foreground.

As planned, **Aero Lloyd Airbus A320 DALAE** aircraft arrived at the test site at around 16:30 when most of the snow on the test track was gone excepting a 5 m to 7 m wide track in the middle. This was slush containing about 50% water. However, the air temperature started to drop (Figure 5) and heavy snow flurry activities started. Visibility decreased to about 400 m. The solid precipitation certainly increased the viscosity of the slush. In fact, at one point, the entire test strip appeared to be covered with fresh snow. There was some accumulation (about 5 mm) of freshly fallen snow on top of the slush. The aircraft tests were completed within about 20 minutes at around 17:00. During this time, $T_a = -1.0^\circ\text{C}$. The passage of the aircraft, however, melted the snow in the central lane used by the aircraft. Figure 6 clearly shows the movement of snow and slush when the aircraft performed a braking run. It also shows the pavement covered with freshly fallen snow.

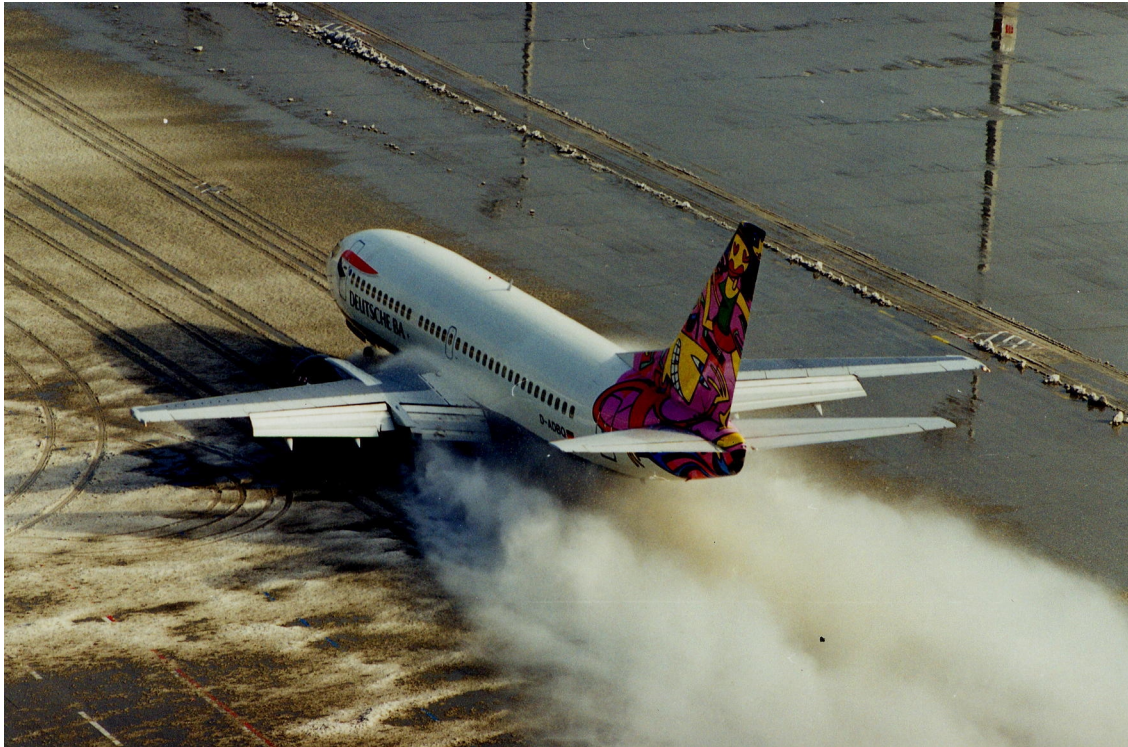
Figure 8. Aerial view of Deutsche British Airways Boeing B737-300 aircraft during the second run on Tuesday 22 February 2000

A braking run by the B737-300 was conducted at 14:16. Figure 8 shows an aerial shot of the aircraft during this run. The photograph also shows the tracks left by the ground vehicles and the aircraft mentioned above. These tracks can be seen in front of the aircraft. Note four tracks on the right side of the strip, produced by the ground vehicles. Three pairs of tracks (two main gears and the nose gear), left by the aircraft during the tare run, are clearly visible on the left side of the strip. Note also the passage of snow and slush over the wing area of the aircraft. This can also be seen in Figure 9 taken from the ground level. Note the flume of slush produced by the nose gear. This photograph also shows the texture of the pavement surface, puddles of water on the pavement and the presence of large, golf-ball-sized ice particles in the contaminant.

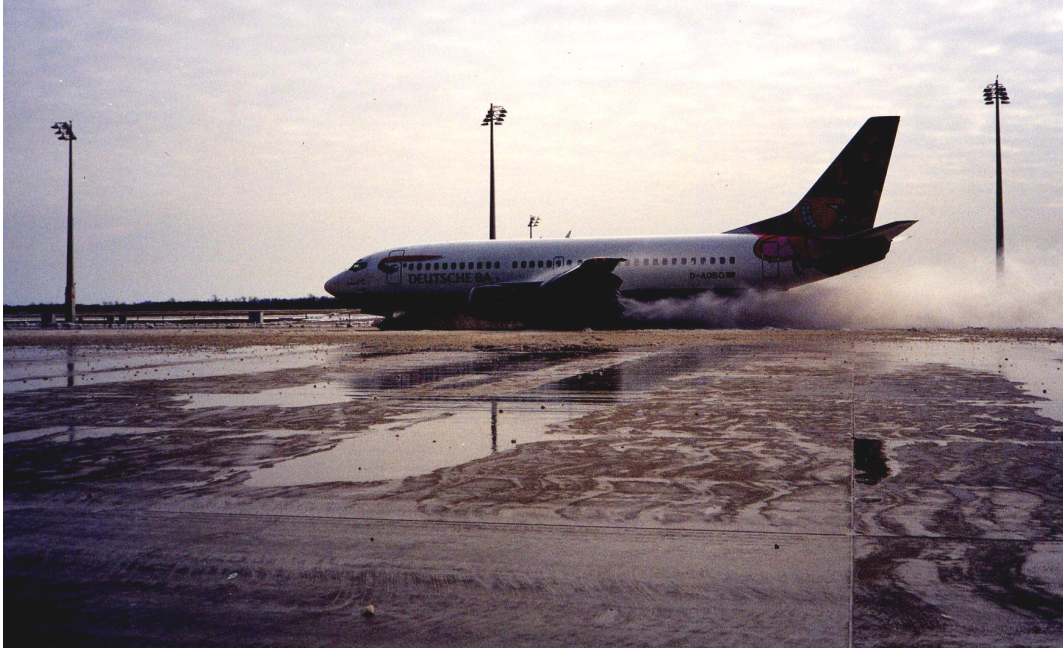
Figure 9. Ground level view of Deutsche British Airways Boeing B737-300 aircraft during the second run on Tuesday 22 February 2000

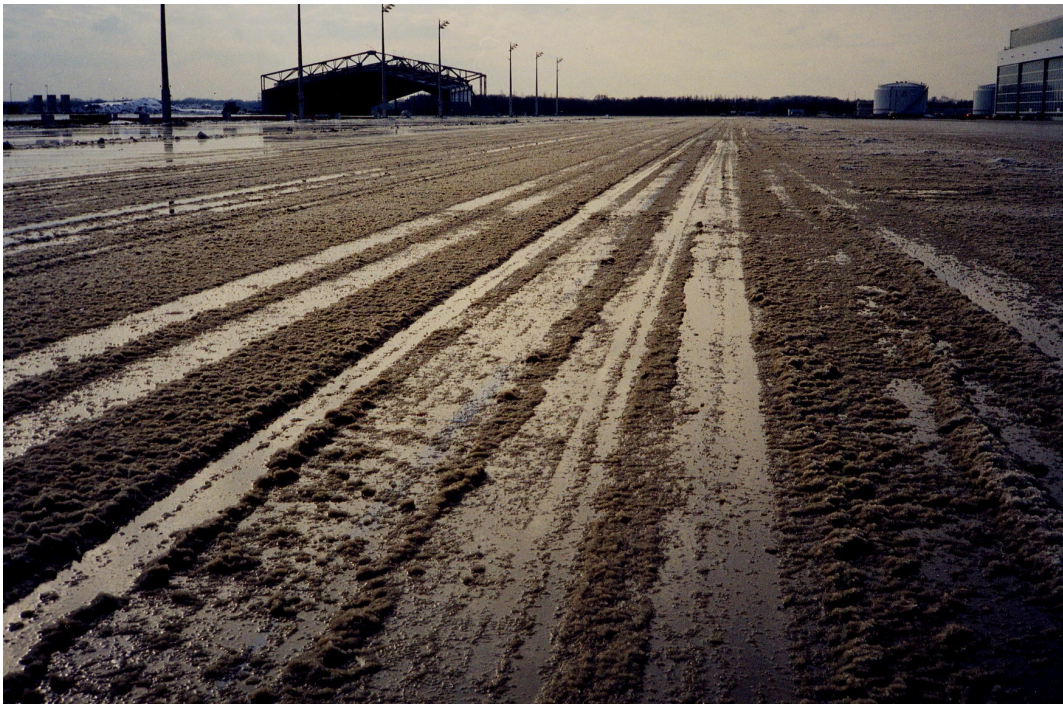
Figure 10. View of the test track, looking towards entrance point, after the last Deutsche British Airways Boeing B737-300 aircraft test at 14:35 on Tuesday 22 February 2000

The aircraft made the third and final run at 14:35. Figure 10, looking towards the entrance point (or 26 direction), shows the condition of the test strip after completion of the last aircraft test.

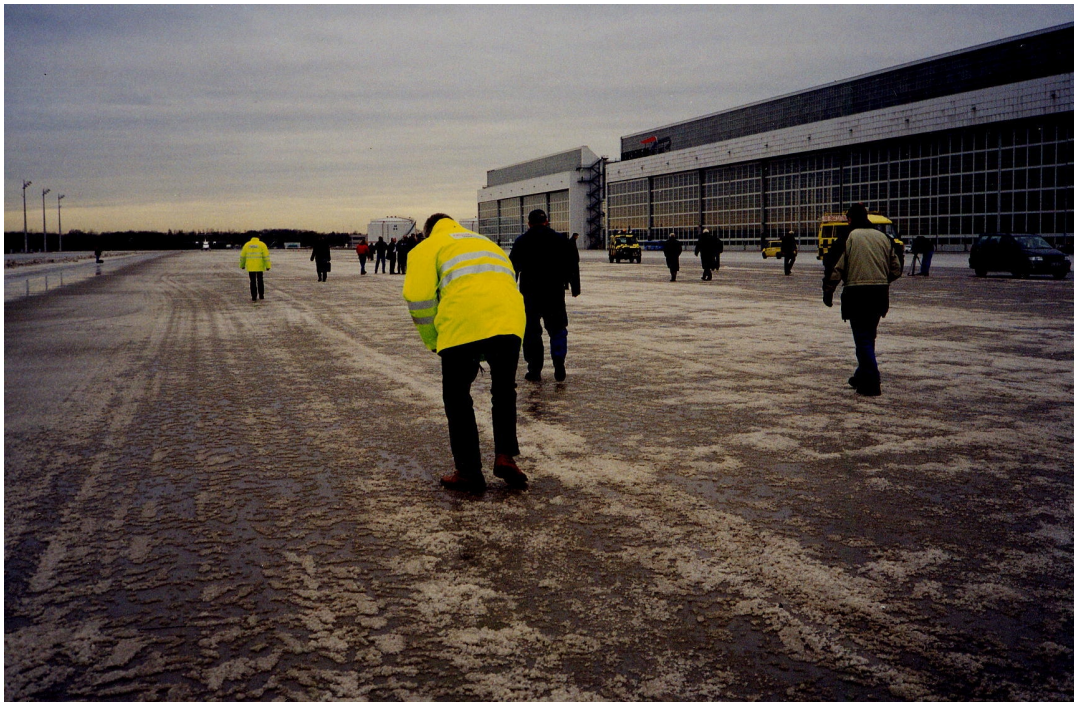
Figure 13. Manual cleaning action of picking up undesirable foreign objects from the strip before the commencement of the Dornier D328-100 aircraft test on 24 February 2000. Note the tire marks left on the snow by the front loader that crushed the large ice particles.

The crew prepared a test strip of melting stored snow in the morning. This test bed was produced with ice particles that varied, as before, between 2 mm and 30 mm. A front loader was used to crush the large particles. The crushing process was induced by dragging the bucket of the front loader along the length of the strip. This dragging process helped in reducing the size distribution of the ice particles, but produced a cover that was not at all uniform. Tire marks were clearly visible (Figure 13). The thickness of the contaminant varied from 0 mm to 10 mm. There were bare and wet patches. The right lane, where the aircraft tests were carried out later, was 80% covered (about 20% bare spots) with wet snow (about 10% water content). The depth of snow varied in the range of 0 mm to 5 mm. The left lane, where the vehicular tests were performed, had a thicker snow cover – up to about 10 mm in thickness. The contaminant had sand and other debris in it. To avoid any further damages to the aircraft, a manual cleaning process was carried out for the first time, by mobilizing all the people at the test site to pick up all visible foreign objects (Figure 13).

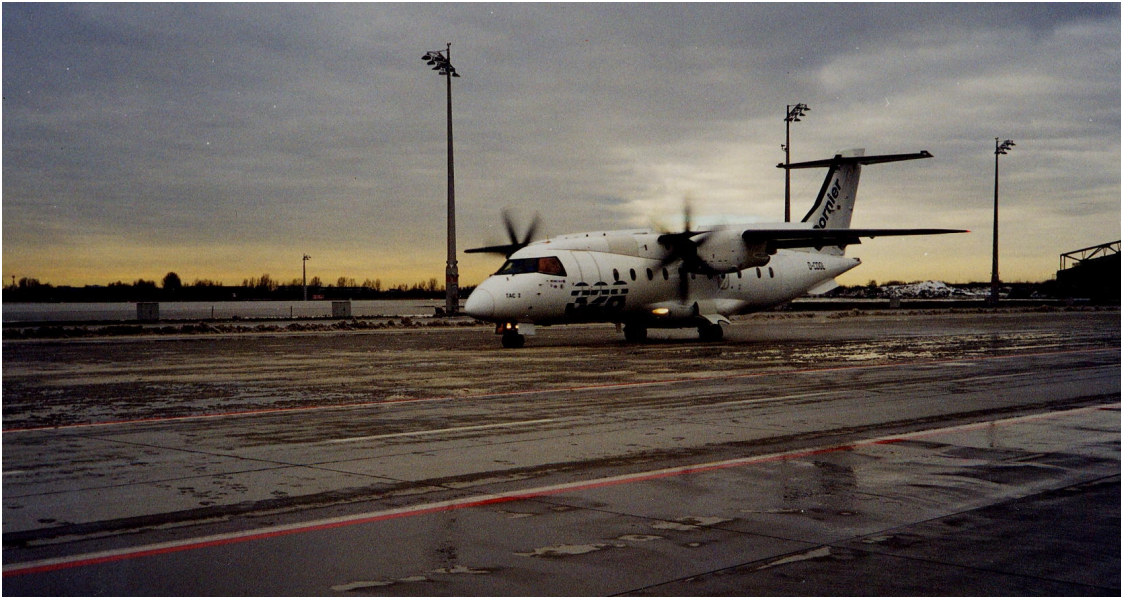
Figure 14. View of the Dornier D328-100 aircraft making a tare run on a freshly prepared and cleaned contaminated strip on 24 February 2000. Note the meltwater formed on the pavement after several runs.

The **Dornier D328-100** aircraft was the first device that was used to initiate the testing of this morning (Figure 14). The aircraft made a slow pass through the right side of the test bed at 09:55. At this time, the air temperature was 3.5°C, the contaminant was wet (about 10% water content), but no standing water was visible.
